Improving the Quality of Magnesium Castings using Modelling and 3-Dimensional Imaging

The purpose of this work was to use 3-dimensional imaging methods such as X-ray tomography and serial sectioning to understand in detail the nature of the defects that form in magnesium alloy castings, and then use modelling and targeted experiments to improve the processing to reduce the incidence of such defects.

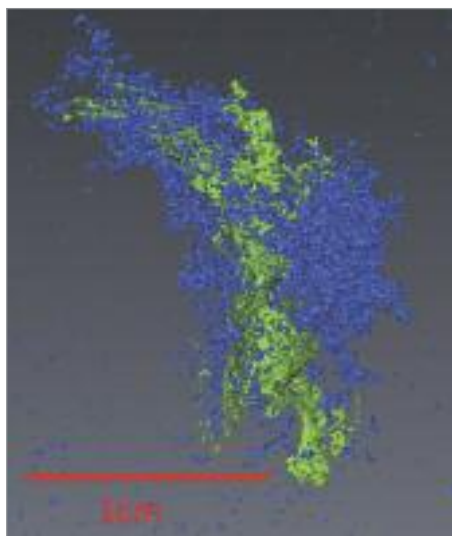
Material containing defects, as identified by ultrasonic inspection, was isolated and examined using 3-dimensional X-ray tomography across a range of length scales. A tomography image of one of the larger defects inspected is shown in Figure 1. It was found that these defects consisted of two main features; an entrained oxide film surrounded by an agglomeration of large intermetallic particles which were identified by EDX analysis as insoluble Al-Mn phase (Al₈Mn₅). Serial sectioning using focussed ion beam milling (FIB) revealed further details, showing that the oxide films contained trapped pockets of gas (Figure 2); it is these trapped pockets that lead to a strong signal response in ultrasonic inspection.

Fig. 1 X-ray tomography image showing a large defect in a magnesium alloy casting. Green regions indicate entrained oxide film, blue indicates large Al₈Mn₅ intermetallic particles

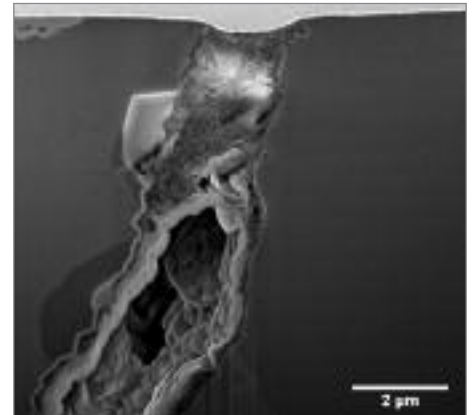
Fig. 2 Slice from serial sectioning experiment revealing a gas pocket trapped between oxide films in a magnesium casting

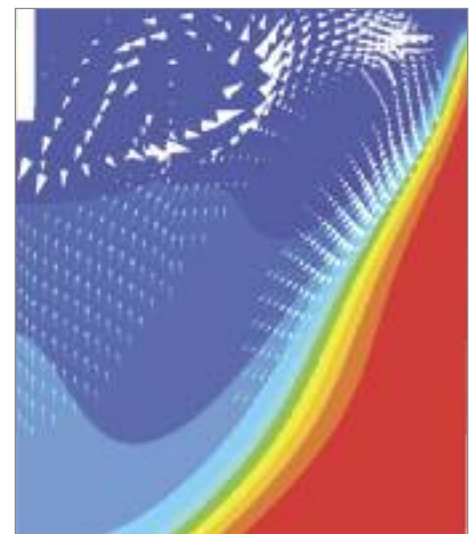
A study of the liquid metal filtering used in the casting process and a simulation of the metal flow (Figure 3) and intermetallic evolution was used to understand the origins of the defects during casting. It was demonstrated that the agglomeration of the oxide and coarse intermetallics, which is particularly undesirable, was produced by a trawling effect as the oxide circulates in the melt pool. The model was used to develop a better casting procedure that provided an improved metal flow path. This was tested and demonstrated to greatly reduce the incidence of oxide becoming trapped, and thus significantly reduce failure rates at ultrasonic inspection.

Fig. 3 Simulation of liquid metal circulation in the sump during casting showing velocity vectors
