## Nanotomography Coupled with RF-GDOES for Evaluation of the Corrosion Performance of Processed Aluminium Alloys

A. Cassell, G. E. Thompson, X. Zhou  
LATEST2, School of Materials,  
The University of Manchester

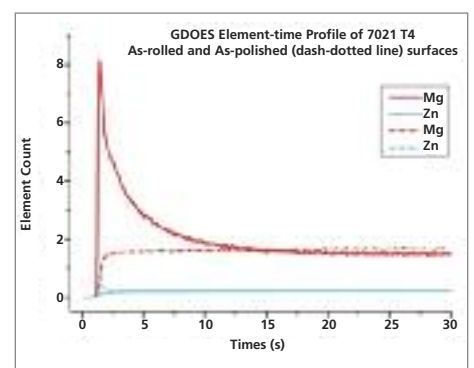
**Fig. 3** The elemental depth profiles for magnesium and zinc which contribute significantly to the corrosion behaviour of the alloy. A sputtering rate of 66 nm/s was achieved. Magnesium oxides are present at the surface after rolling.

Elemental depth profiles of the same commercially produced alloy are provided by radio frequency glow discharge optical emission spectroscopy. Analysis of the first few microns of the rolled surface can provide accurate readings relating to elemental concentrations present within the near-surface region, as shown in Figure 3. Such analysis helps to correlate the corrosion behaviour of the alloy to the distribution of the chemical species in the near-surface region of the alloy.
